Manhole Inspection Summary

Manhole # S27I__032MH

Insp Date: **5/27/08 1:50 PM**

Location Address: **111 Parkin st**

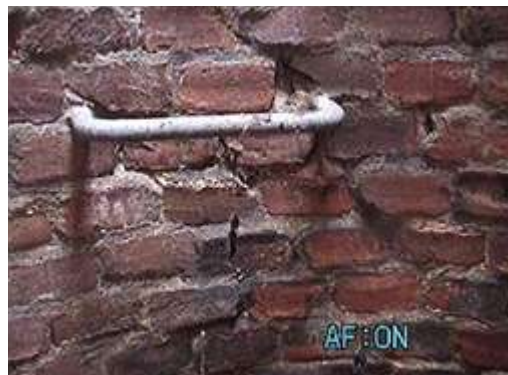
Defect 1

Condition: ☐ Sound ☒ **Cracked** ☐ Root Intrusion ☒ **Loose Brick** ☐ Deteriorated

Infiltration: ☐ None ☐ Joint ☐ Cracks ☐ Mortar ☐ Roots ☒ **Wall**

barrel flow wall, barrel cracked, cracks, mortar

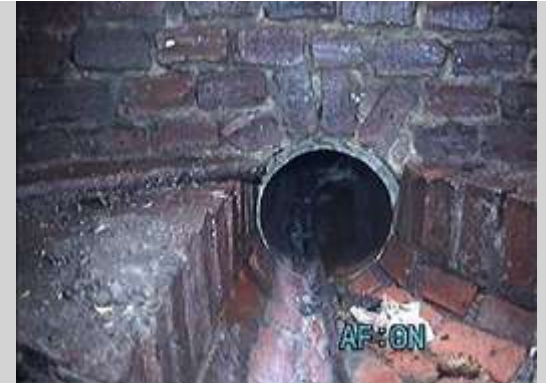
12 O'Clock Outflow

Pipe Height: **8.4** (in.) Rod and Bar (Angled)
Pipe Material: **Clay** ☐ Pipe Lined
Invert Depth: **10.22** (ft.) Flow Characteristics: **Fast**
Deposits: ☒ None ☐ Mud ☐ Sludge ☐ Debris ☐ Grease
Silt Depth: **0** (in.) Deposits Extent:
Infiltration: **None** Pipe Seal Cond: **Sound**

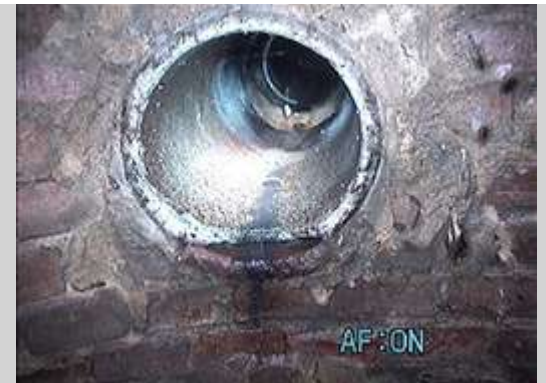
3 O'Clock Inflow

Pipe Height: **8.4** (in.) Rod and Bar (Angled)
Pipe Material: **Clay** ☐ Pipe Lined
Invert Depth: **8.63** (ft.) Flow Characteristics: **None**
Deposits: ☒ None ☐ Mud ☐ Sludge ☐ Debris ☐ Grease
Silt Depth: **0** (in.) Deposits Extent:
Infiltration: **None** Pipe Seal Cond: **Sound**

Drop: **Inside** Rod and Bar
Angled: **Yes** Reading: **9.14** (ft.)
Inv Depth: **10.14** (ft.)

Drop Condition: **Open**

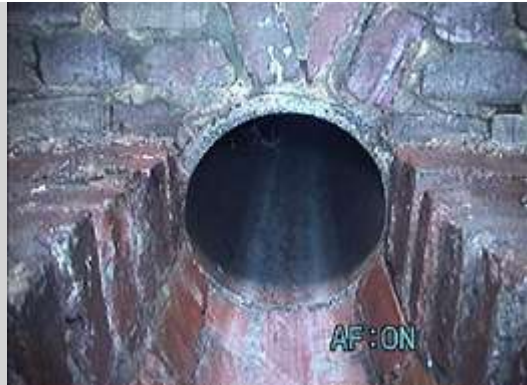
6 O'Clock Inflow

Pipe Height: **8.4** (in.) Rod and Bar (Angled)

Pipe Material: **Clay** ☐ Pipe Lined

Invert Depth: **10.03** (ft.) Flow Characteristics: **Fast**

Infiltration: **None** Pipe Seal Cond: **Sound**
